ShipConstructor 2012 Update: Important Information

In order to prevent an error when updating your project to ShipConstructor 2012, manual steps are required prior to updating a project in order to check for, and potentially correct erroneous data.

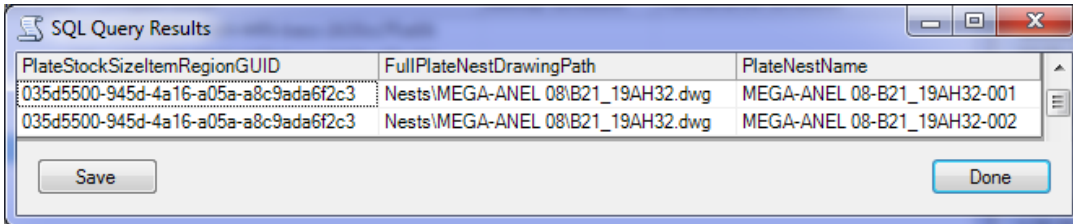
The screenshot below shows two nests, 'MEGA-ANEL 08-B21_19AH32-001' and 'MEGA-ANEL 08-B21_19AH32-002' nested on the same remnant identified by the remnant GUID '035d5500-945d-4a16-a05a-a8c9ada6f2c3'. The `_SCEDITSTOCK` command should be used in the drawing 'Nests\MEGA-ANEL 08\B21_19AH32.dwg' to change the stock plate of either 'MEGA-ANEL 08-B21_19AH32-001' or 'MEGA-ANEL 08-B21_19AH32-002'. When this action is completed and the drawing saved the check script may be rerun in Administrator to see that the conflict no longer exists.

Screenshot showing the Remnant GUID, The drawing name and path, and the plate nest names which are both using the remnant.

If the results of the check operation have one or more lines *as illustrated in the example following this procedure*, then the command SCNESTEDIT must be used to change the stock of all but one of the nests nested on the same remnant (Remnant GUID is listed in the first column) to another unique stock plate.

1. Using the information in the *Query Results* window open each drawing containing a multiple nest on a single remnant and perform the following;
2. Locate the incorrect nest, select it, and run the *Edit Stock Part* command (*_SCNESTEDIT*), select a new stock, and then apply the changes;
3. Save the drawing.
